## J/80 Review & Best Practices—Part I

Following two separate incidents in the past 12 months where 15+ year old J/80s suffered apparent keel stub failures, J Boats has compiled, with the help of several industry experts, the following “best practices” inspection, maintenance and use guide for J/80 owners. We urge each owner to read carefully the recommendations, to proactively and periodically inspect all critical components of your boat, and to contact anyone in the J/80 network of dealers, builders and class associations if you need any assistance.

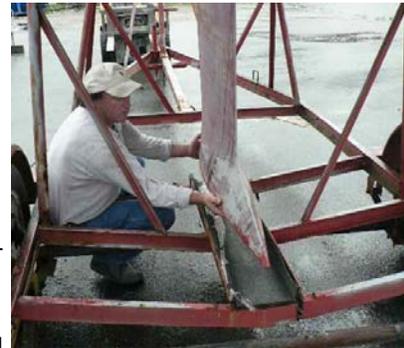
1. With your boat suspended from travel lift straps (OK) or braced in a cradle (best) or trailer (good), grab the keel at the bottom and forcefully rock it back and forth. This **tip deflection test** on a deep keel boat should create a small amount of flex over the keelspan and sump (if solid fiberglass like the J/80), but there should otherwise be minimal movement from side to side. When you release the keel it should immediately return to position (and not continue to cycle). It is also important to have someone belowdecks to check for movement in the keel floor or bilge area, or any evidence that the sump is moving independently of the keel floors.

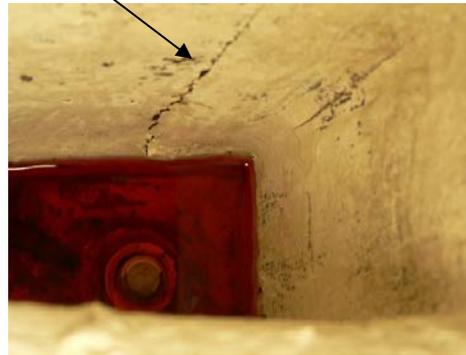
from the hull). The picture to the right shows an example of delaminated tabbing. If there is any sign of different color gelcoats or paint, it is likely the keel sump has been previously repaired. When in doubt, sand away any gelcoat, clean area with a solvent, and look for white crazing in the laminate-- this may be a sign of delamination. Have a surveyor immediately inspect this area for structural integrity.

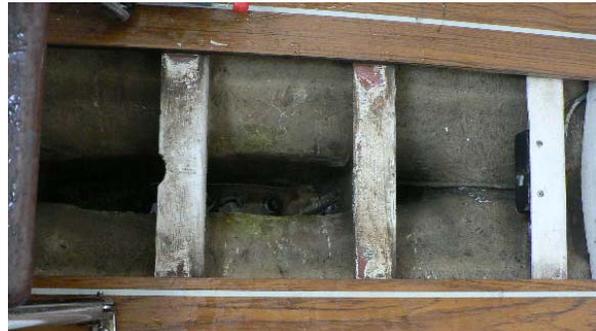
*Here's a J/80 bilge that hasn't seen soap in years. Note evidence of high water present over long period of time.*

- Care should be taken to avoid having standing water in the bilge. Not only does standing water accelerate corrosion of wiring, fasteners and keel bolts over time, it ruins floor boards and interior woodwork. As the gelcoat/ paint ages in the bilge area, bilge water can eventually seep into the fiberglass laminate by way of pin holes in the gelcoat and weaken the fiberglass laminate structure. The process of hydrolysis can be initiated in the fiberglass laminate anytime there is ingress through cracks in the paint/gelcoat in the bilge. The process of hydrolysis is persistent and invisible- it's water that chemically degrades the quality and strength of the laminate over time. Bilges (all areas under the floorboards, not just the centerline bilge) should be cleaned thoroughly once per year and then every five years recoated with fresh gelcoat or epoxy paint to ensure proper protection. In northern climates, water turns to ice in the winter. If moisture gets into the laminate and freezes, this can rapidly accelerate deterioration in the laminate. The New Hampshire Materials Testing Labs website ([www.nhml.com](http://www.nhml.com)) has an informative article on hydrolysis, see Newsletter of May 1, 2006.

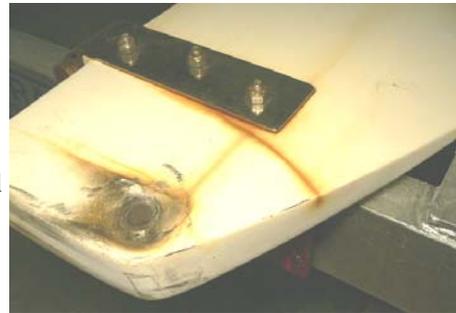
2. The J/80s rudder blade itself should be checked for pin holes or other cracks that might allow water migration. Check also for splits on the bottom, leading edge and trailing edges. Weighing the rudder on an annual basis is a good way to monitor whether it may have absorbed water which could lead to a weakened laminate structure. When a transom hung rudder breaks it's usually just under the bottom gudgeon. A simple side to side flex test (grasping the rudder bottom and moving side to side with tiller secured amidships) can indicate whether the blade is weakened or showing cracking at the lower gudgeon area.
